# COMBINED FIRE AND HEALTH & SAFETY RISK ASSESSMENT.

| Address of premises: | Helmsdale,<br>Greenmeadow,<br>Swindon,<br>SN25 1RA |
| Date of fire risk assessment: | 18 <sup>th</sup> September 2024, Reviewed September 2025 |

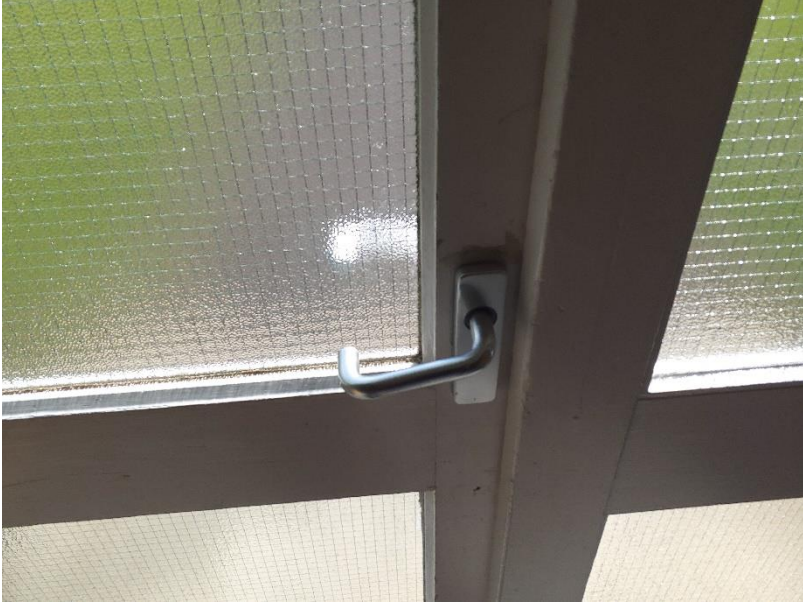
| <p>It was noted during this fire risk assessment that there was not building security in place for each block. It is recommended that the RP instructs a suitably qualified and competent contractor to install an appropriate lock mechanism which automatically locks once the door is closed in order to secure the building from opportunist arson.</p> <p>The building perimeter was found to be clear of any fire load at the time of this assessment.</p> | | |

| <p>03</p> | <p>It was noted during this fire risk assessment that there was not building security in place for each block. It is recommended that the RP instructs a suitably qualified and competent contractor to install an appropriate lock mechanism which automatically locks once the door is closed in order to secure the building from opportunist arson.</p> | <p>2</p> | <p>B</p> | <p>Action required RP to consider installation of door locks or other means of upgrades</p> |

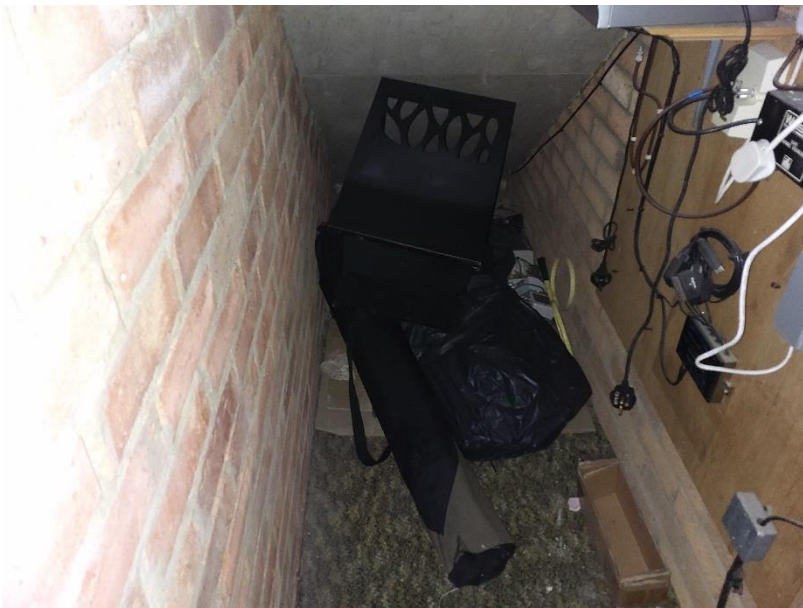
| <p>Housekeeping was found to be of a poor standard at the time of this assessment within blocks 97-107, 121-131 and 133-143 with the electrical intake cupboards being used for storage. This presents a fire load within a high-risk room containing an ignition source. It is therefore recommended that the RP has all storage removed and residents are reminded to keep all electrical intake cupboards sterile at all times.</p> <p>Waste is well managed with a bin store located away from the building.</p> | | |

| <p>04</p> | <p>Housekeeping was found to be of a poor standard at the time of this assessment within blocks 97-107, 121-131 and 133-143 with the electrical intake cupboards being used for storage. This presents a fire load within a high-risk room containing an ignition source. It is therefore recommended that the RP has all storage removed and residents are reminded to keep all electrical intake cupboards sterile at all times.</p> | <p>2</p> | <p>B</p> | <p>Ongoing Action required Contractor to remove items.</p> <p>DH monitor area.</p> <p>Residents are advised to keep sterile areas.</p> |

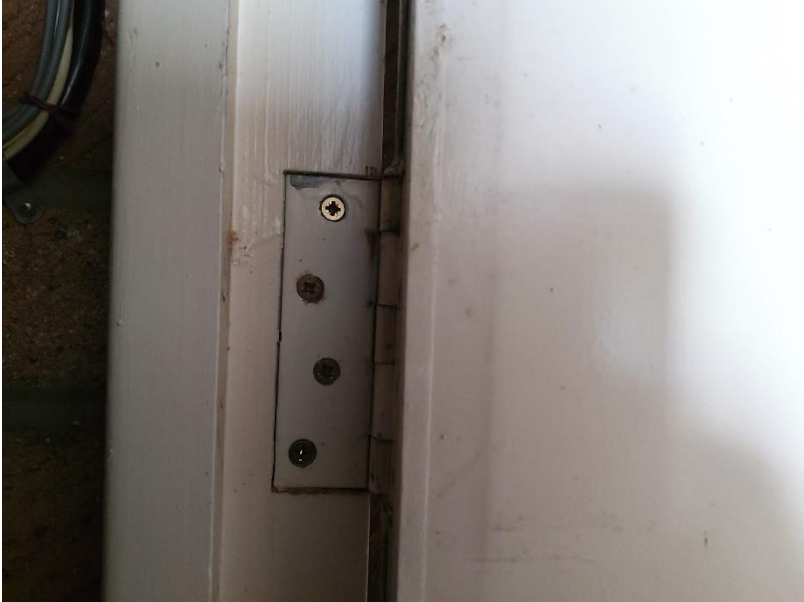
| 06 | <p>It was noted during this fire risk assessment that the electrical intake cupboard doors within all blocks were hung on three non-fire rated hinges. It is recommended that the RP instructs a suitably qualified and competent contractor to replace these hinges in order to maintain the integrity of the doorset.</p> | 3 | B | Action Complete |

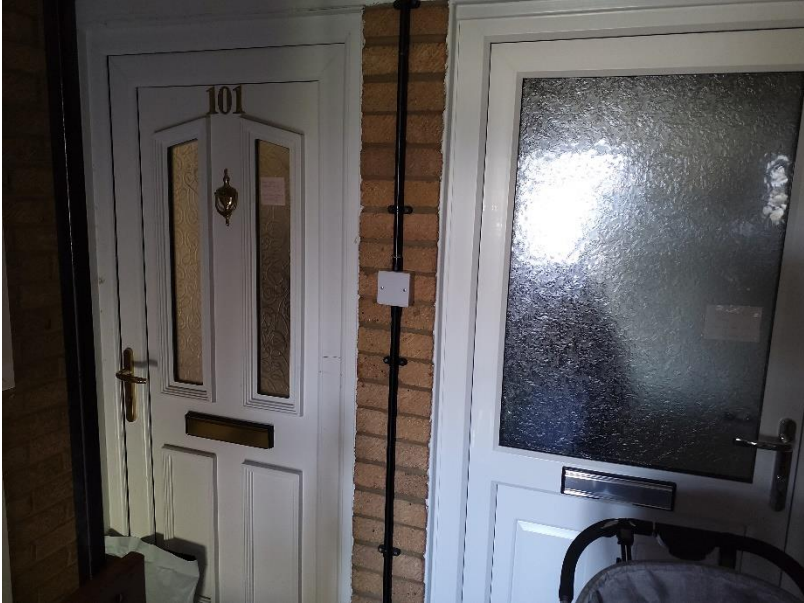
| <p>08</p> | <p>It was noted during this fire risk assessment that multiple doors within all blocks have had the original doors replaced with UPVC which cannot guarantee a minimum of 30 minutes fire resistance. This could allow smoke and fire to spread into the means of escape which could compromise the stay put policy and impede persons escape from other units. It is therefore recommended that the RP instructs a suitably qualified and competent contractor to replace all UPVC doors with a FD30s fire doors complete with three grade 13 hinges, combined cold smoke and intumescent seals and an overhead closer in order to protect the means of escape as per Fire Safety (England) Regulations 2022 Fire Door Guidance Section 6.7A.</p> <p>Furthermore, it is essential that each flat entrance door is a suitable fire door, providing a minimum of thirty minutes fire resistance, hung on three grade 13 hinges and having a functioning self-closing device fitted that positively closes the door on the latch, together with smoke and intumescent seals. It is recommended therefore that the RP instruct a suitably qualified and competent contractor to conduct a fire door inspection to all flat entrance doors and communal area doors providing advice on suitability. Any shortcomings identified by this inspection should be addressed as a priority by upgrading or replacing the door.</p> <p>Flat entrance doors, communal area doors, the seals and the self-closing devices should then be subjected to an annual inspection and maintenance schedule.</p> | <p>1</p> | <p>B</p> | <p>Action required<br/>DH to inform owners accordingly.</p> <p>Last inspection<br/>July 2025.</p> <p>Apartment doors belong to apartment owner.</p> <p>Owners are provided with information as required.</p> |
